Structural Engineering Appraisal Report

Project No. 20438

Plumpton Pavilion,
King George V Playing Field,
Plumpton Green
Lewes
BN7 3DP

POTTINGER D S I ENGINEERING N	Project Ref.	20438	
	Project Name	Plumpton Pavilion	
	Document No.	20438-DOC-1000	
	Prepared By	G. Pottinger	Page 1

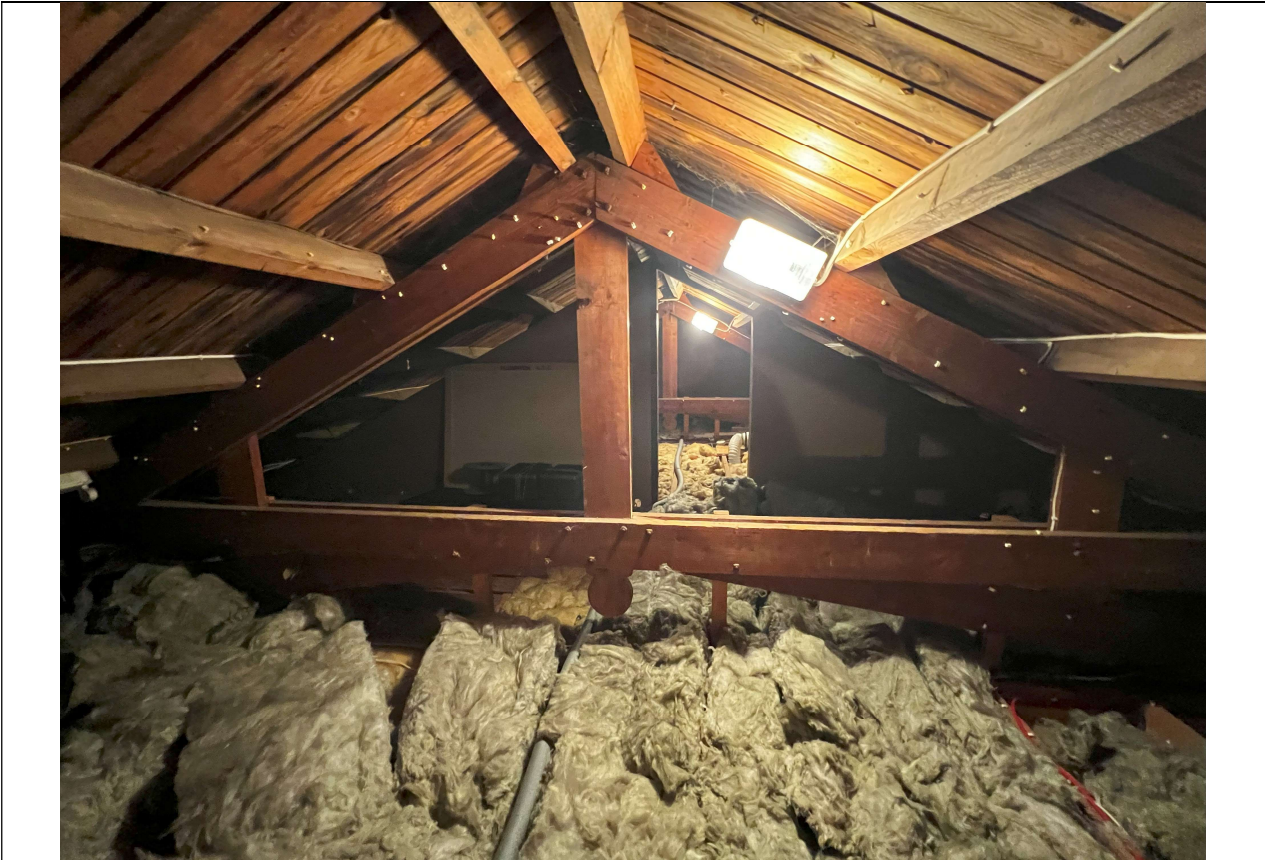
Hatch 1 provided access to the roof space of Building 1, which was constructed with timber purlins and ornate king post trusses. Structurally the roof was in good condition, with no significant defects observed.

Building 1 Roof Structure

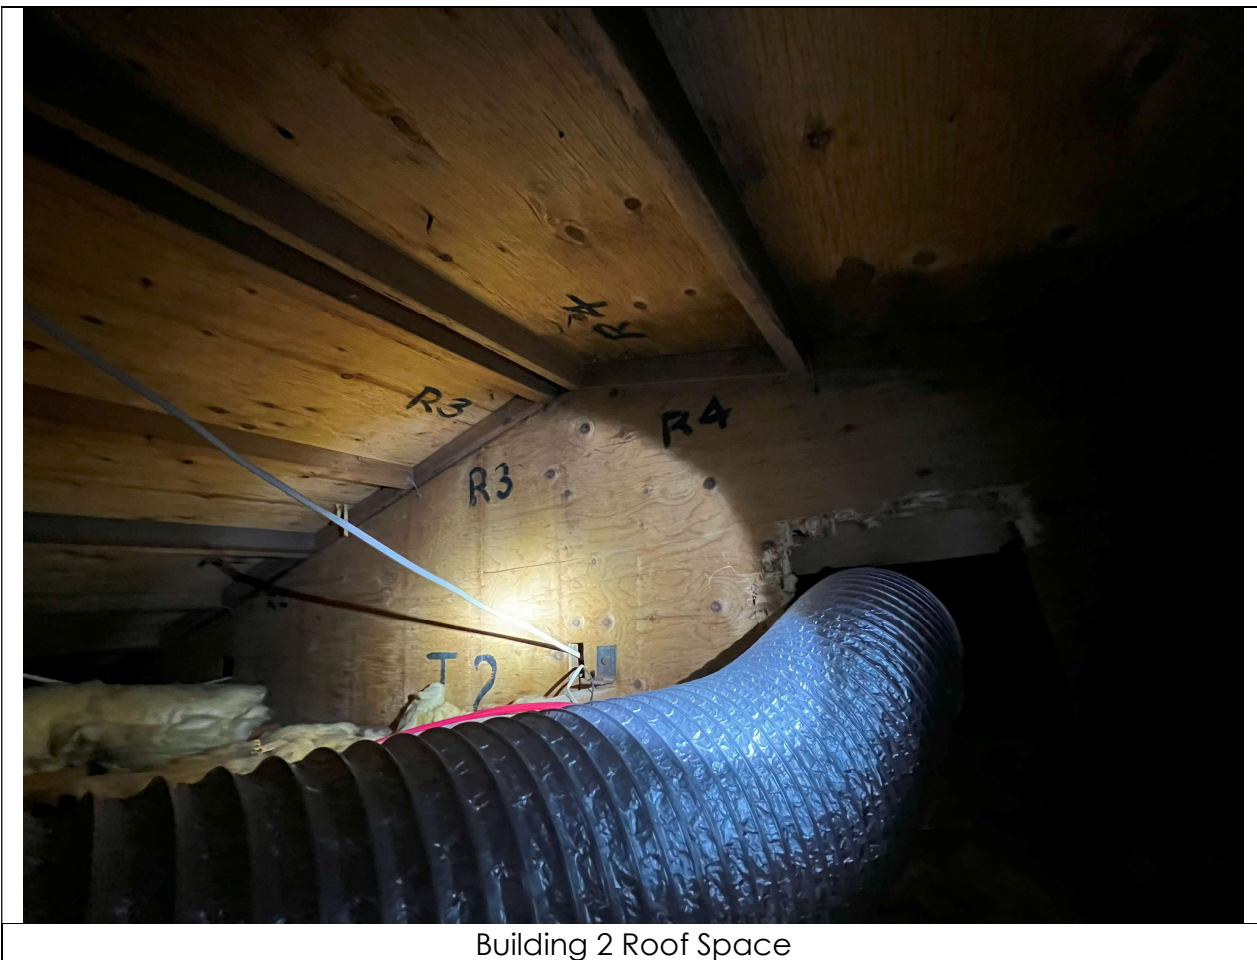
Hatch 2 provided access into the roof space of Building 2, which is constructed timber purlins on plywood trusses. Numerous services holes have been made in the plywood trusses. Otherwise, the structural elements appeared in good condition.

Building 2 Roof Space

The roof structures appear generally in good structural condition overall. Strengthening may be required to the plywood trusses where large service holes have been cut. The penetrations in the gable end of Building 3 should be sealed to prevent the ingress of insects and water.

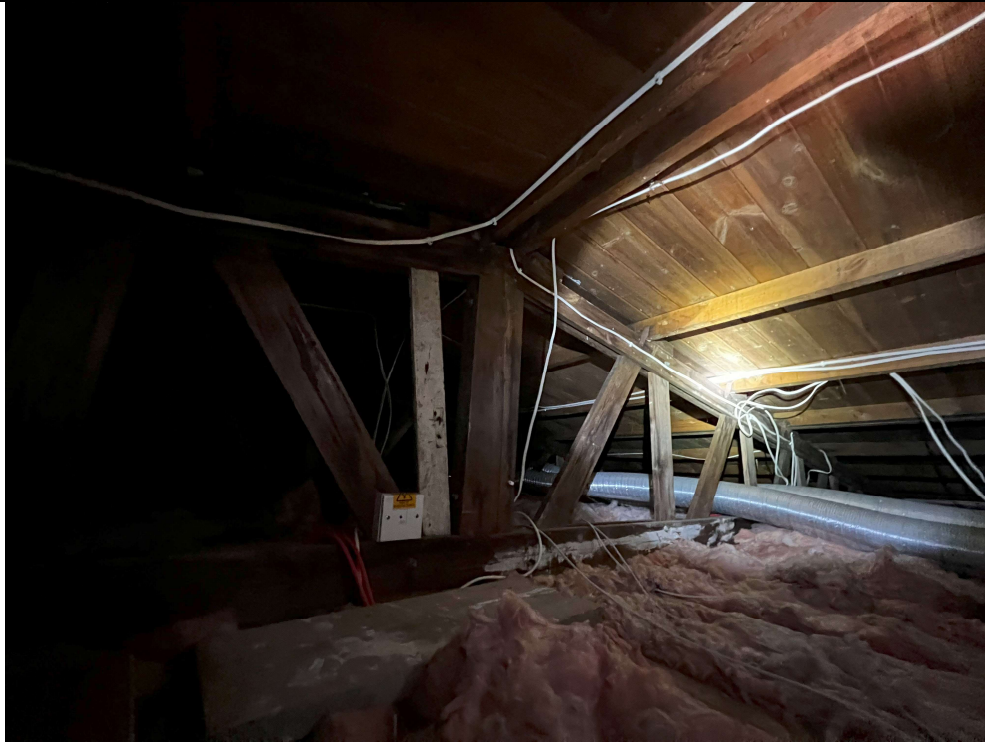
Hatch 3 provided access into the roof space of Building 3, which is constructed in timber purlins with timber modified queen type trusses. The structural elements were observed to be in good condition. However, numerous penetrations were observed in the gable end facing the cricket, providing a possible route of ingress for insects to attack the timber, or the ingress of water.

Building 3 Roof Space

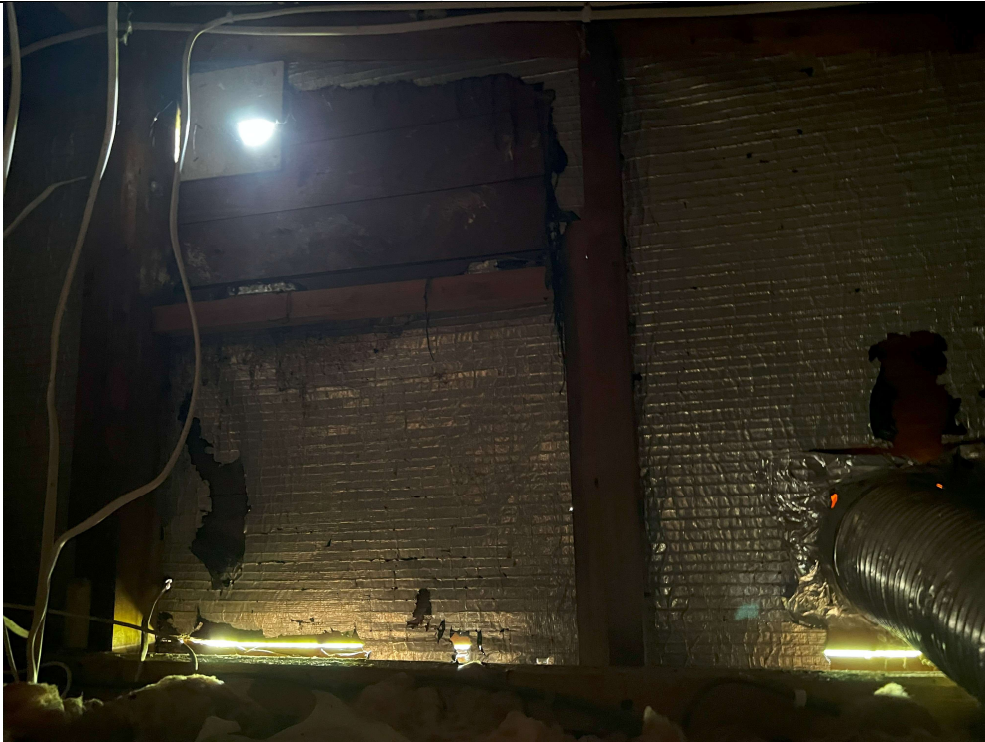
Building 3 Gable End

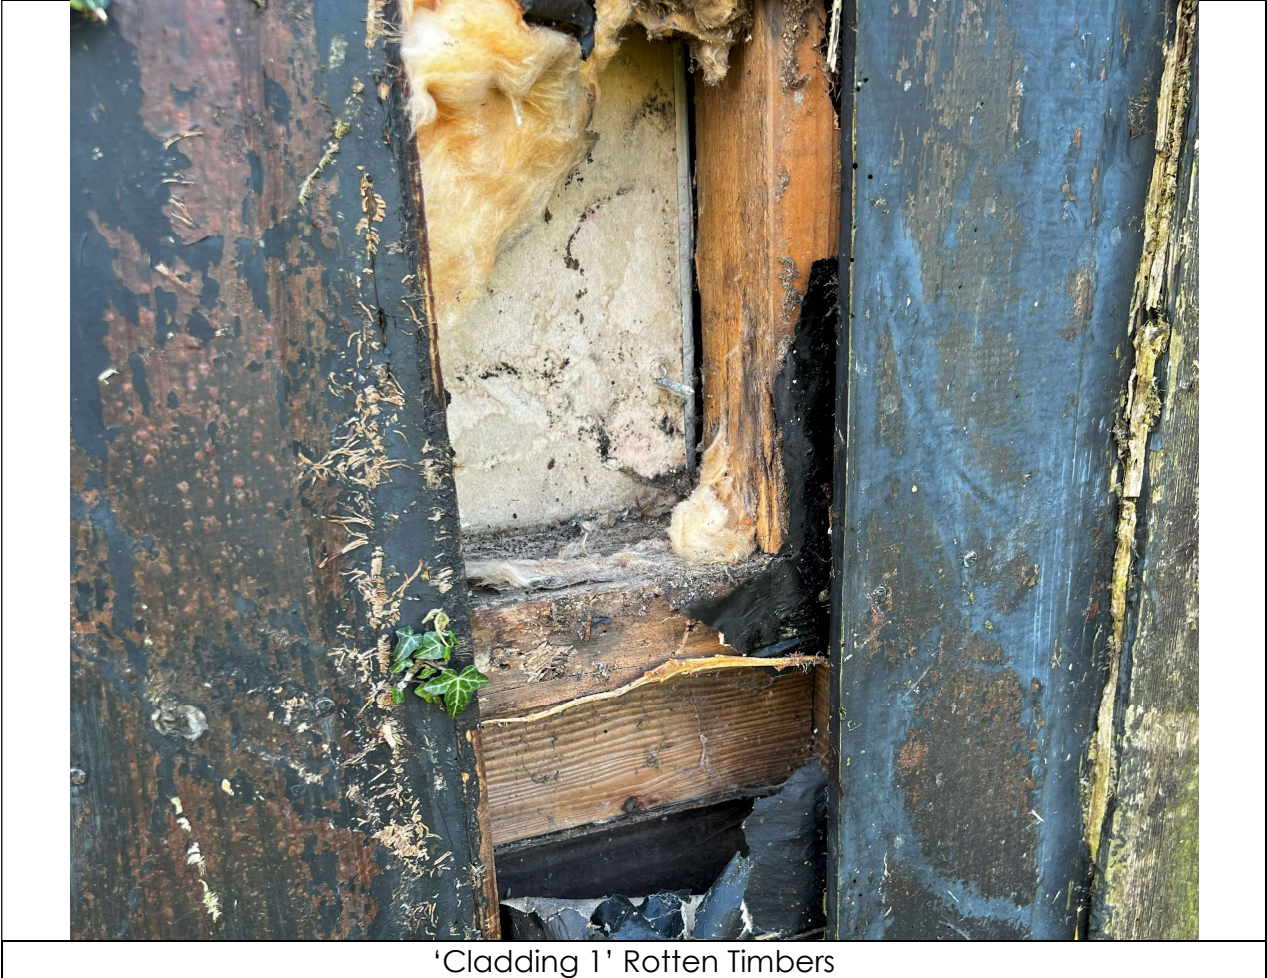
The timber cladding removed at the area noted as 'Cladding 1' was observed to be significantly rotten. Where removed, the loadbearing timber stud walls behind also were observed to be significantly rotten.

'Cladding 1' Rotten Timbers

The timber studwork where exposed was found to be significantly rotten. It is understood that the timber behind the new composite cladding was repaired/replaced during the recladding works, but the remaining timber cladding has now largely failed and allowed the timber studwork behind to rot and need to be replaced.

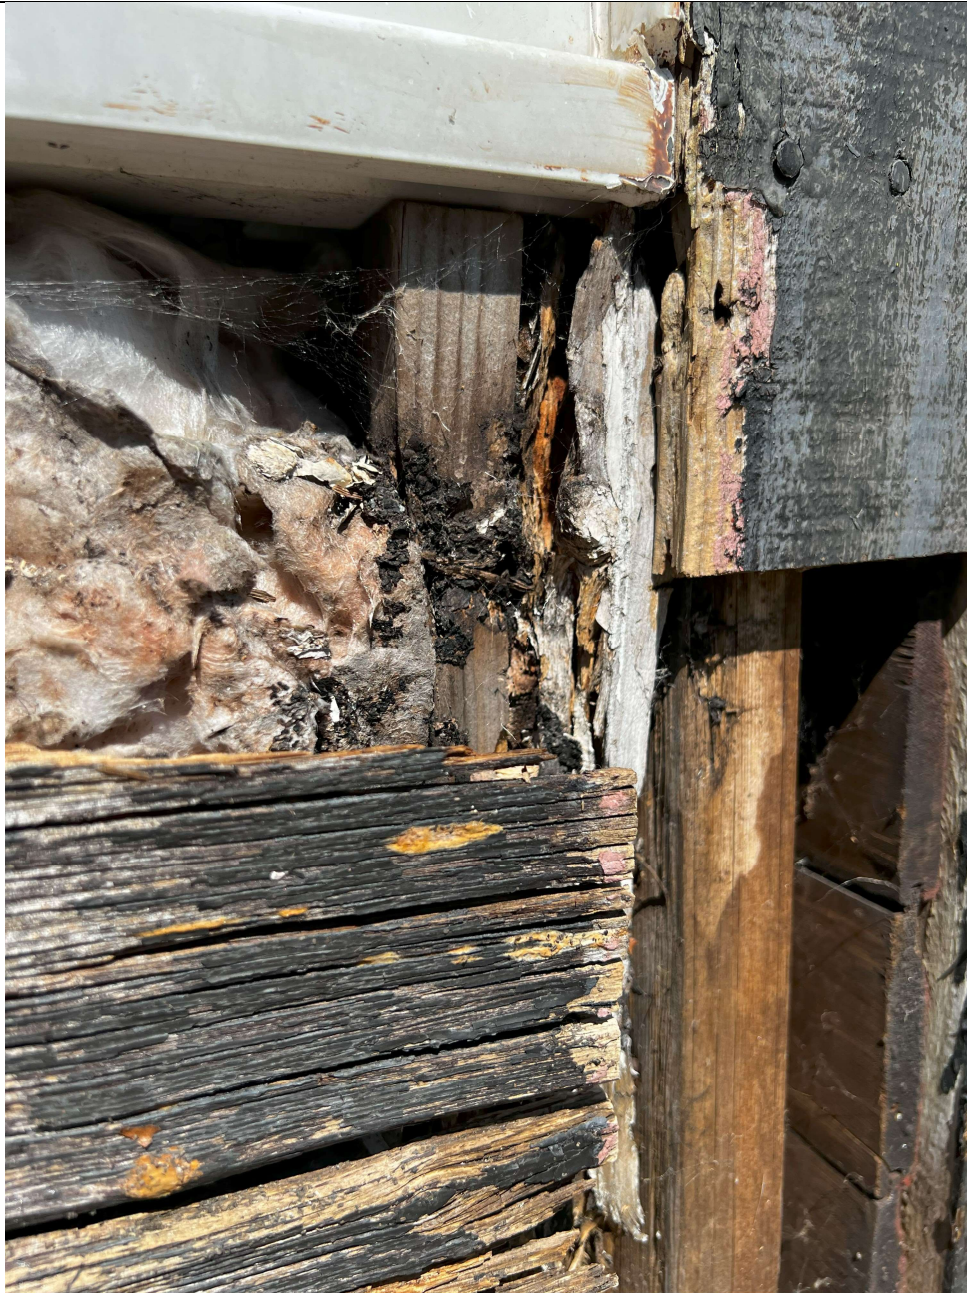
The timber cladding removed at the area noted as 'Cladding 2' was also observed to be significantly rotten. Again, where removed the loadbearing timber stud walls behind also were observed to be significantly rotten.

'Cladding 2' Rotten Timbers

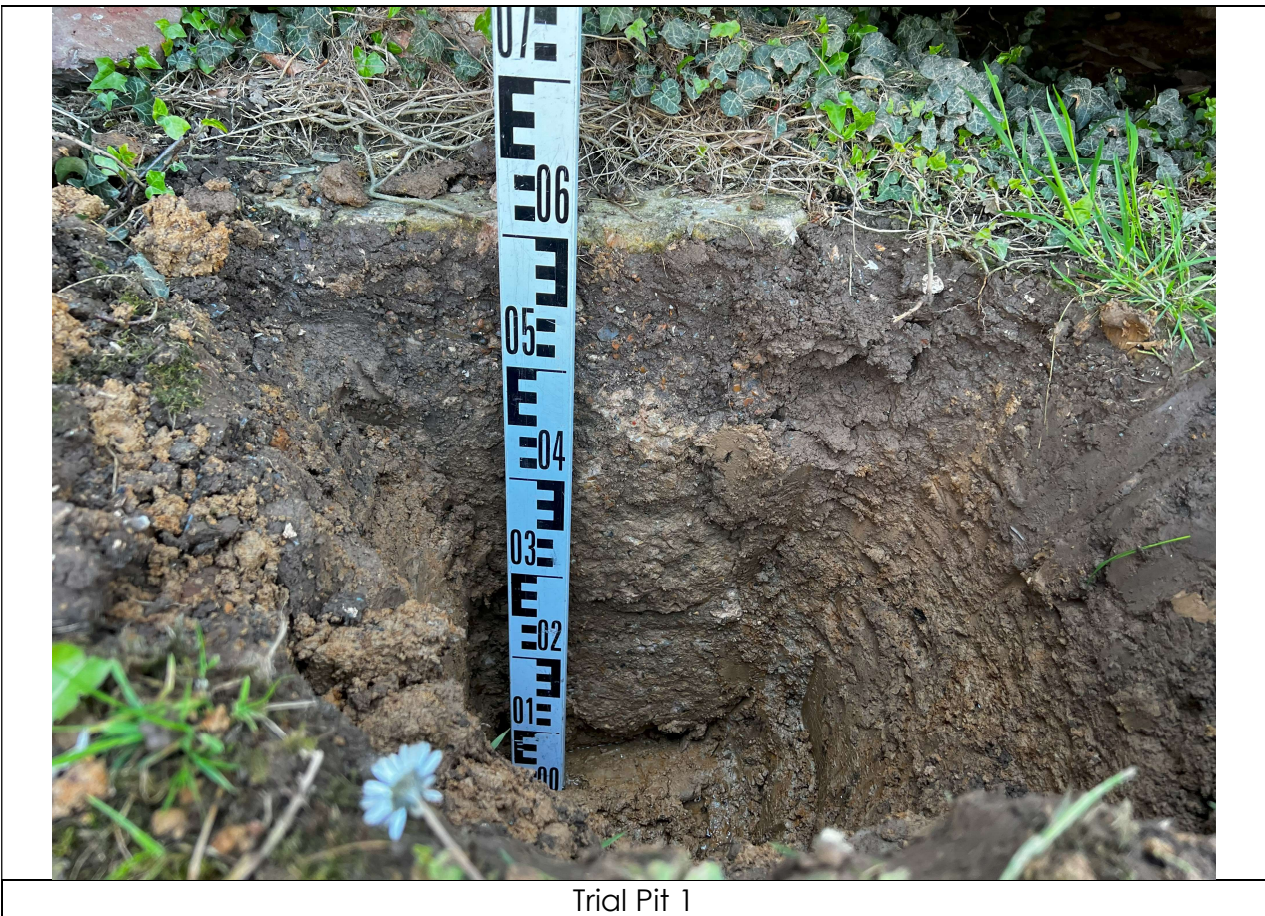
3.7 Floor Structure and Foundation Observations

Trial Pit 1

The soil was observed to be a sandy clay, but without laboratory testing it is not possible to confirm the volume change potential (which dictates the required footing depth). However, from what was observed the foundation depth would need to be at least 750mm below ground level, and possibly as deep as 1.5m below ground level. Any future structural alterations which sought to reuse the existing footings would therefore require some degree of underpinning to comply with current building regulations.

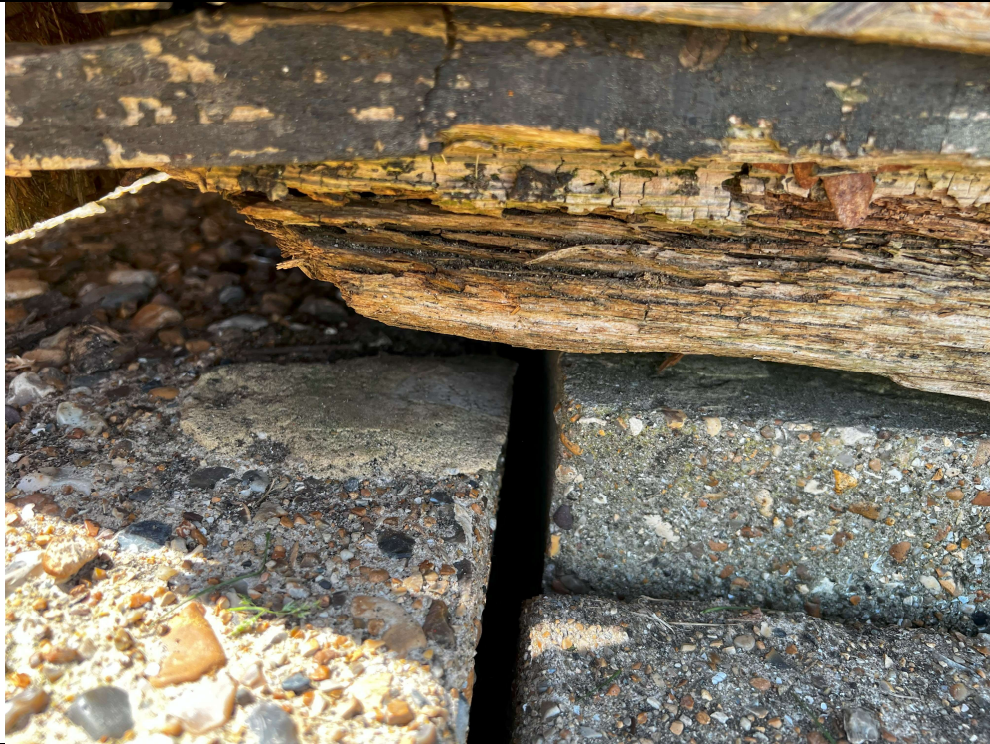
Rotten Timber Beam Bearing

Timber beams, where rotten, will need to be replaced. It was noted that the adjacent ground level nearest the skate park does not provide sufficient protection to the beams from splashing/puddles etc. so would need to be lowered or another form of moisture protection installed. The incorrectly installed floor joists will require some form of strengthening or connecting detail to be installed for them to adequately span between beams.

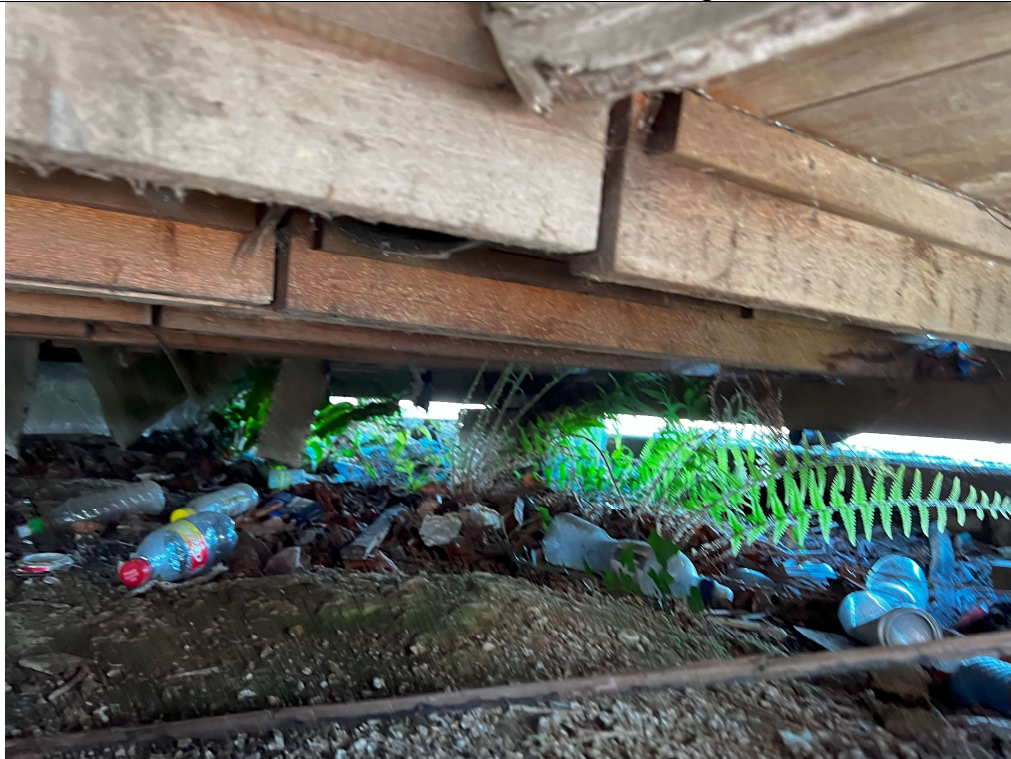
Incorrectly Installed Floor Joists
