Topographical Survey Layout

Drawing Title: Topographical Survey P3/4

Job Title: Plumpton Pavilion, Plumpton Green, Lewes, BN7 3BW

Drawing Title: Elevations

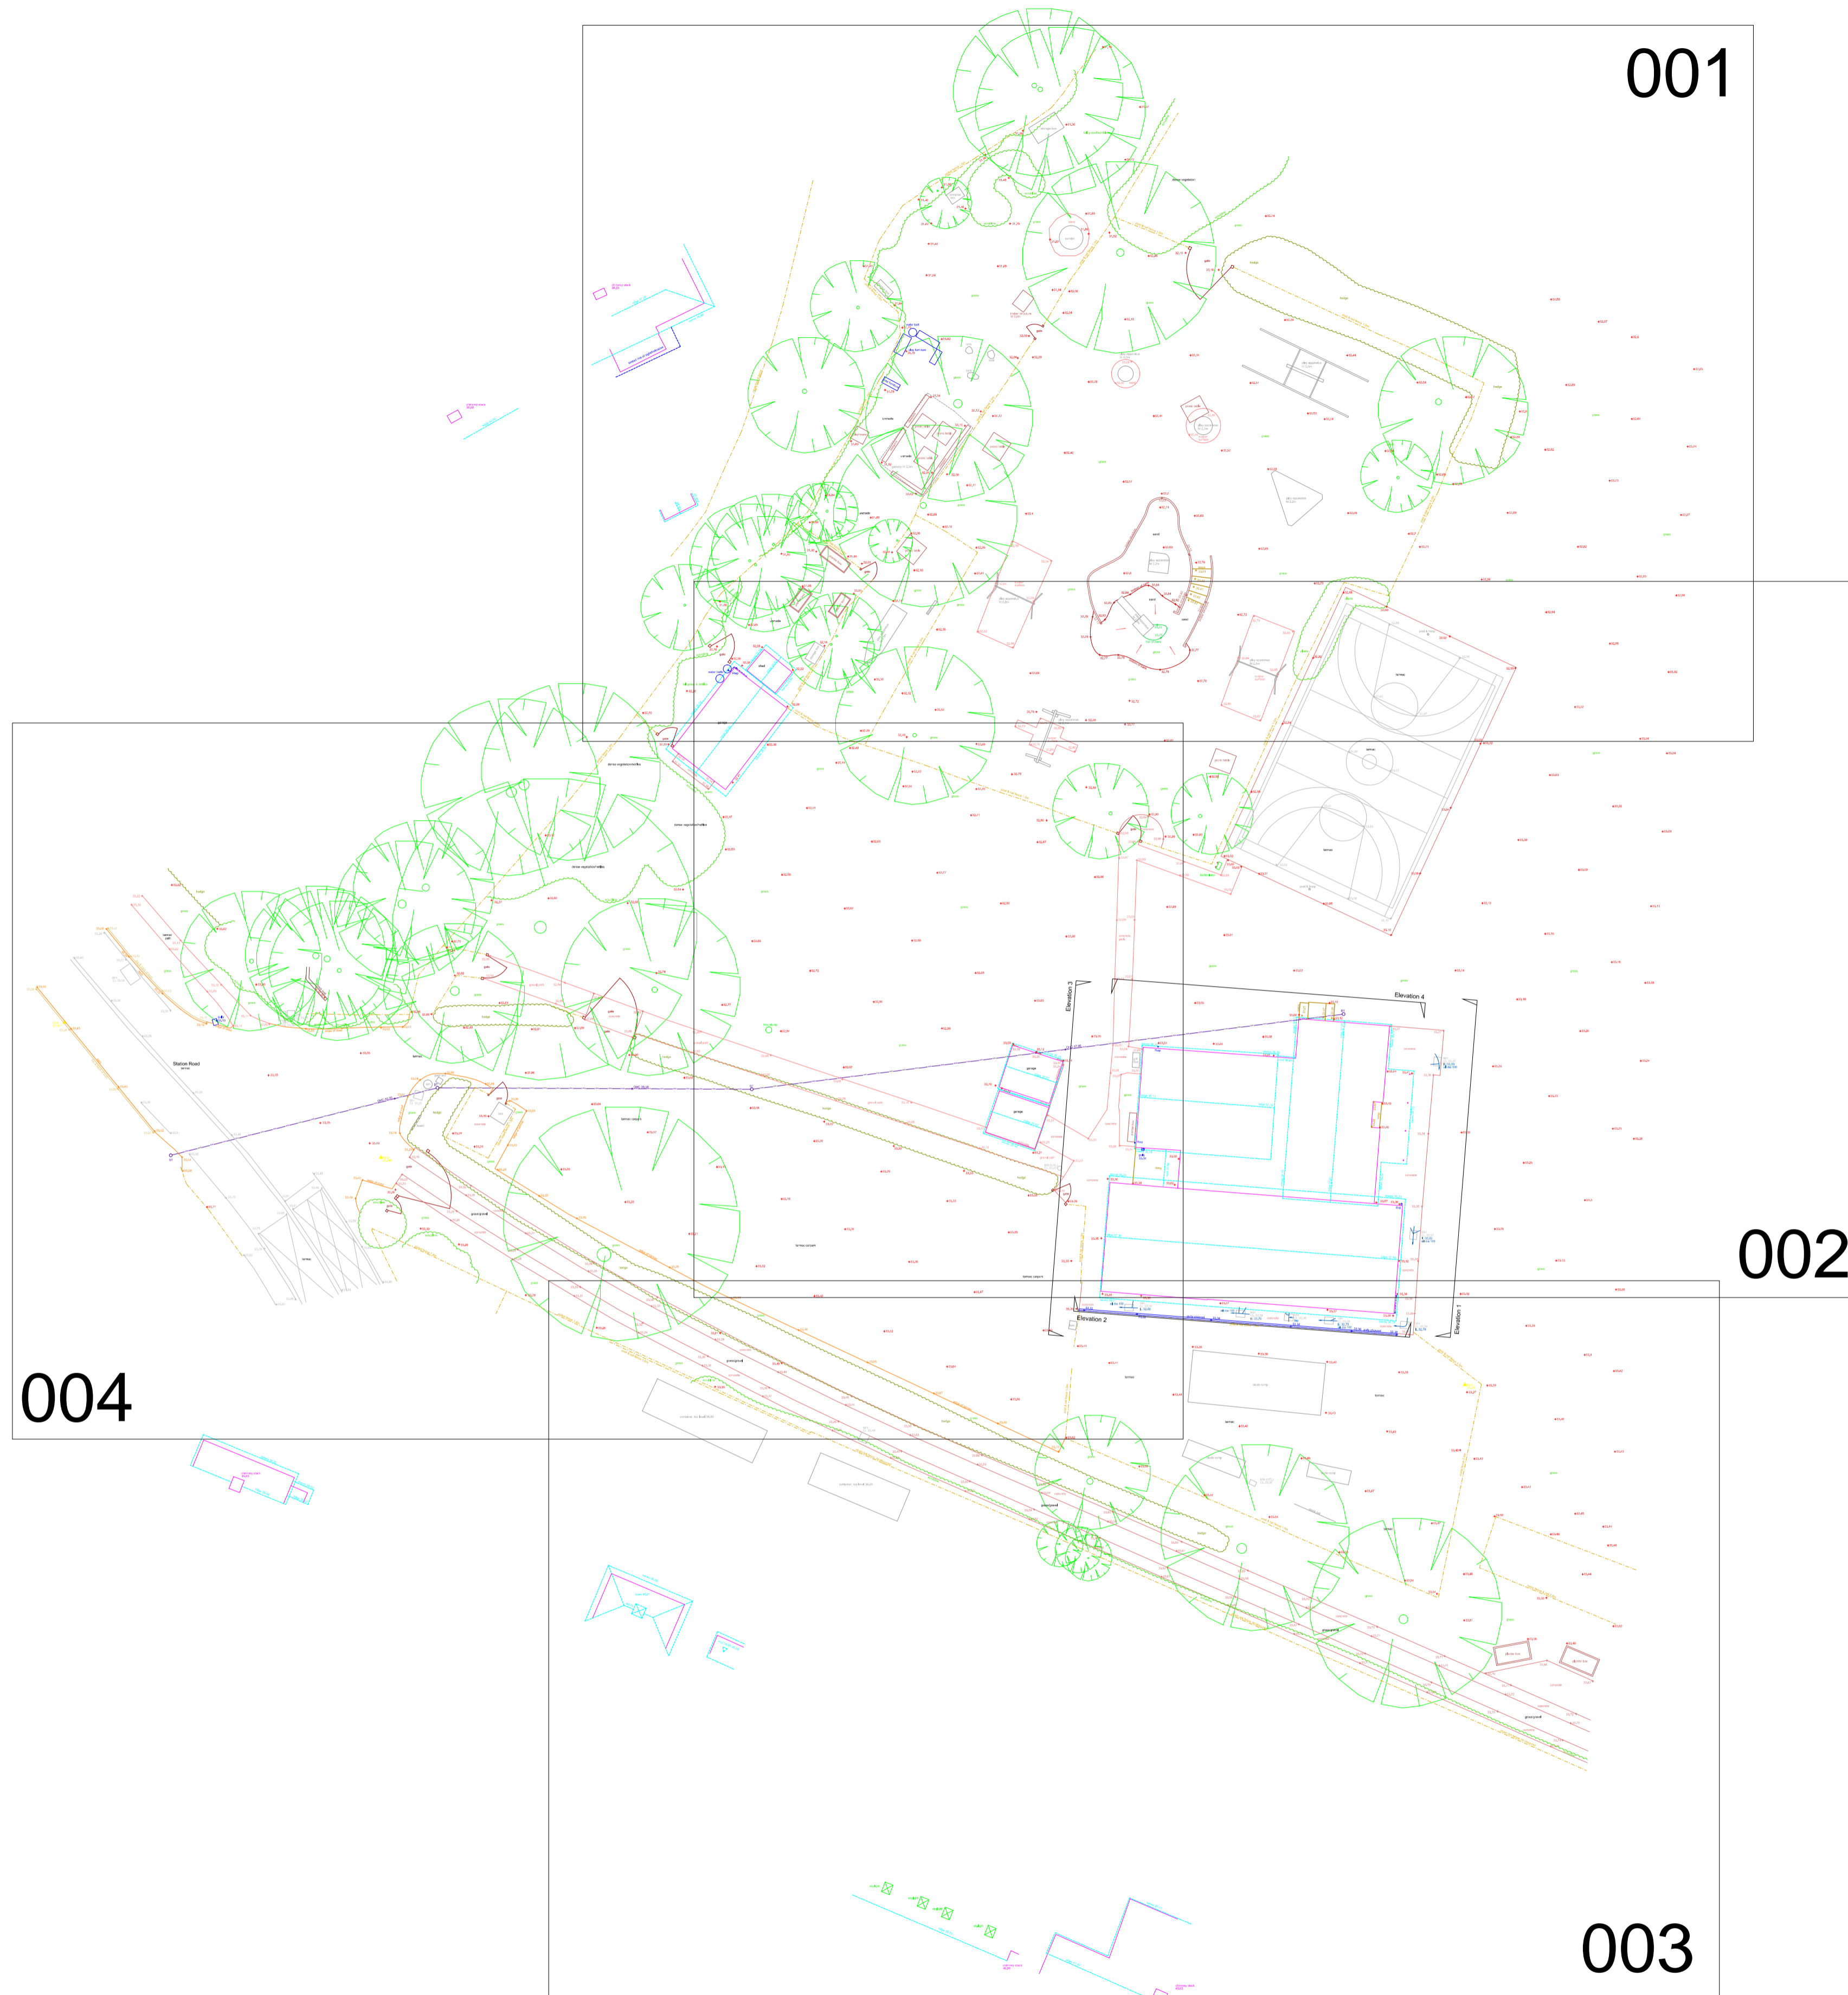
NOTES
 SURVEY IS BASED ON OS GRID SYSTEM
 ORIGINATING FROM STATION 1
 @ E 536476.196, N 116130.883, RL 33.567
